Final  
Report

March 1972

# Composite Overwrapped Metallic Tanks

1. Report No. NASA CR-120888		2. Government Accession No.		3. Recipient's Catalog No.	
4. Title and Subtitle COMPOSITE OVERWRAPPED METALLIC TANKS				5. Report Date March 1972

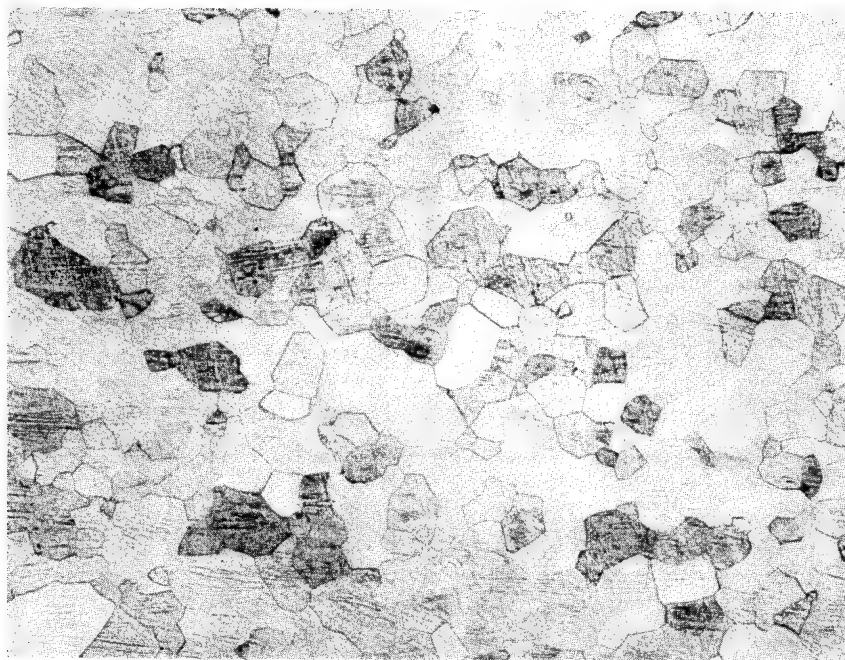
A metallurgical investigation as to the cause of failures was then undertaken. The normal cause for forming failures in titanium (a hard face-oxidized surface and contamination) was suspect. Investigation revealed that improper annealing by the producer rather than contamination was the cause. Mill records were studied and it was determined that one group of the plates had been annealed at 1500°F for 30 minutes and the second group at 1500°F for 15 minutes. While normal tensile tests did not reveal the lack of a proper anneal, the photomicrographs left no doubt as to the material condition. Photomicrographs (Fig. 7 and 8) show the heavily textured grain structure with no indication of alpha surface scale. All the formed domes listed in Tables 1 and 2 exhibited crosshatched microcracks (Fig. 9). The crosshatched microstructure automatically scrapped all domes that had been produced to this point even though they did not indicate conditions of surface cracking. The normal equiaxial grain structure for this alloy is shown in Figure 10.

Figure 10 Photomicrograph of Properly Annealed  
Ti-5Al-2.5Sn (ELI)

Attempts to return the material to the producers were fruitless and, since replacement appeared out of the question, it was determined that a proper annealing cycle must be developed to salvage the remaining material. This was accomplished, and a period of four hours at 1650°F in a vacuum followed by a furnace-cool proved to be the optimum cycle. The full report of the failure analysis and supporting technical data may be found in the appendix. The ABAR vacuum furnace at the Denver Division facility was not large enough to economically anneal the blanks. The only other suitable, certified vacuum furnace in the area was located some 60 miles away in Colorado Springs at the Proto Shop. This furnace, an Ipsen, contained automatic controls, proper temperature and pressure readouts, and recording equipment. After thoroughly discussing the problem, arrangements were made with the very cooperative Proto Shop management to give the titanium annealing effort first priority. A maximum effort to properly anneal the material for explosive forming and to provide "in process" annealing between shots was undertaken. The annealing for the remaining supply of blanks began on April 23 and was completed on May 23. In the meantime, blanks were being given their first explosive-forming shots, process annealing, and second shots, etc, as rapidly as

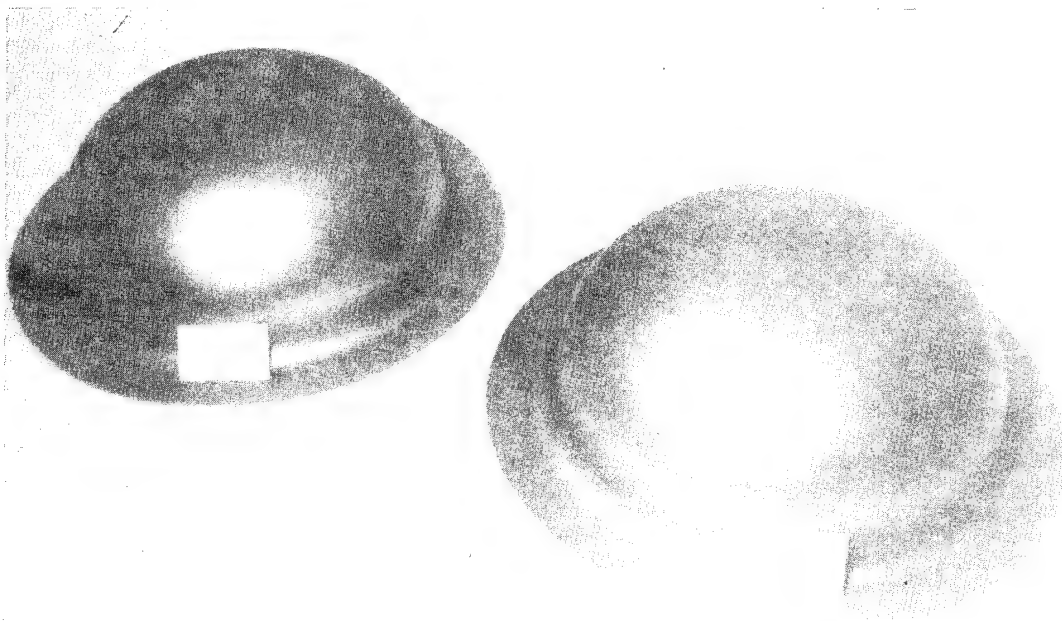
At this point, metallurgical analysis had identified a number of potential causes of the failures but most all causes centered around the material surface condition. As a result, a complex processing system was developed.

Figure 12 Fully Formed Domes Coated with Turco Pretreat Prior to Annealing in Air Furnace

In general, before and after each dome-forming operation, the dome had to be annealed. The dome was prepared for annealing by chem milling 0.005 inch maximum per surface and coating with Turco Pretreat (Fig. 12) to prevent oxidation. After annealing, the Turco Pretreat was removed by again chem milling the dome. This processing sequence proved successful and no further dome cracking was experienced.

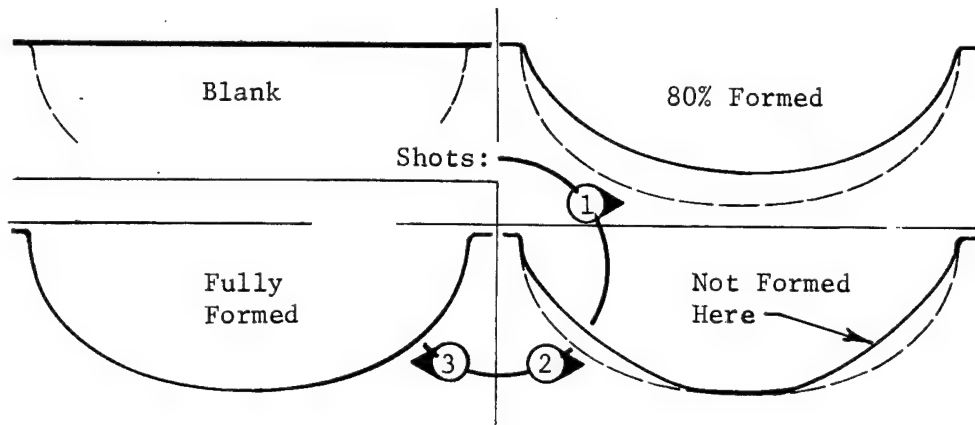
Figure 17 shows the explosive-forming sequence and contour deviations.

Raw Material Thickness Deviation:  $0.220 \begin{matrix} +0.046 \\ -0.010 \end{matrix}$  in.

Best Deviation from Contour (H-2):  $-0.030, +0.050$  in.

Figure 17 Explosive-Forming Sequence

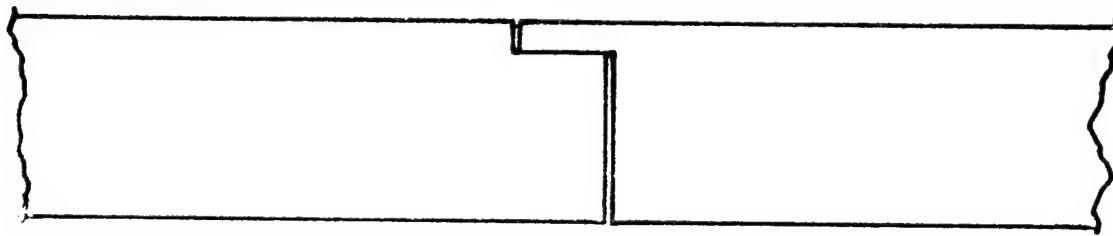
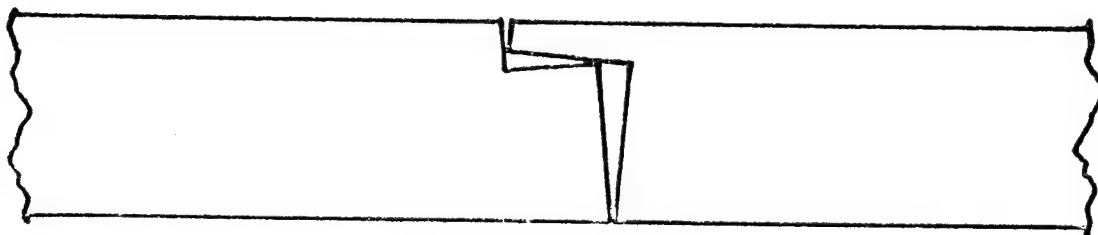
Joint Design

After S/N 1 failed during the hydrostatic sizing operation, a failure analysis uncovered lack of fusion in the girth joint. As a result S/N 2, which had been completed, was returned for rework. Rework consisted of removing both interlocking step joints at the girth. Although a new barrel was used for reassembling the tank liner, some volume was lost due to elimination of the old weld area on both domes. The barrel and domes were prepared for final welding by machining a straight butt joint and tack-welding the barrel and dome together.

As-Assembled Joint

(Poor Fitup due to Machining Tolerances and Dome Out-of-Roundness)

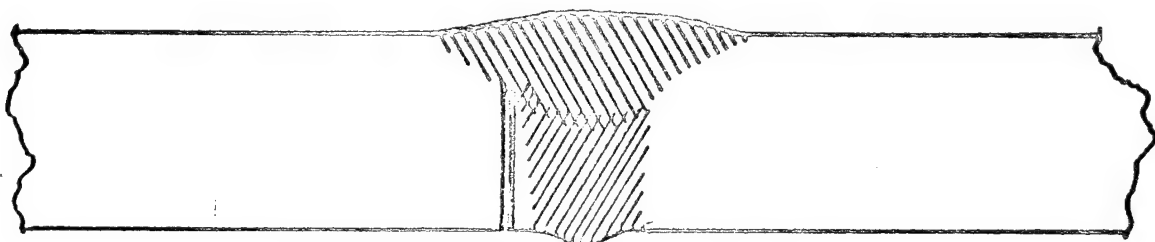
Figure 35 illustrates the lack of fusion on S/N 2 when the single-pass weld technique simply missed the joint. The only thing holding the joint together was the cosmetic pass over the outside for smoothing out the contour. The lower portion of Figure 35 illustrates how the triple-pass weld technique would solve any misalignment encountered. Due to the acceptable results of the tensile tests, the remaining tank liners were joined at the girth with three parallel adjacent welds. No further lack of fusion problems occurred in the girth joints.

Electron Beam Weld Off  $\phi$  of Joint

Figure 35 Defective Single-Pass Electron Beam Weld and Proper Triple-Pass Weld

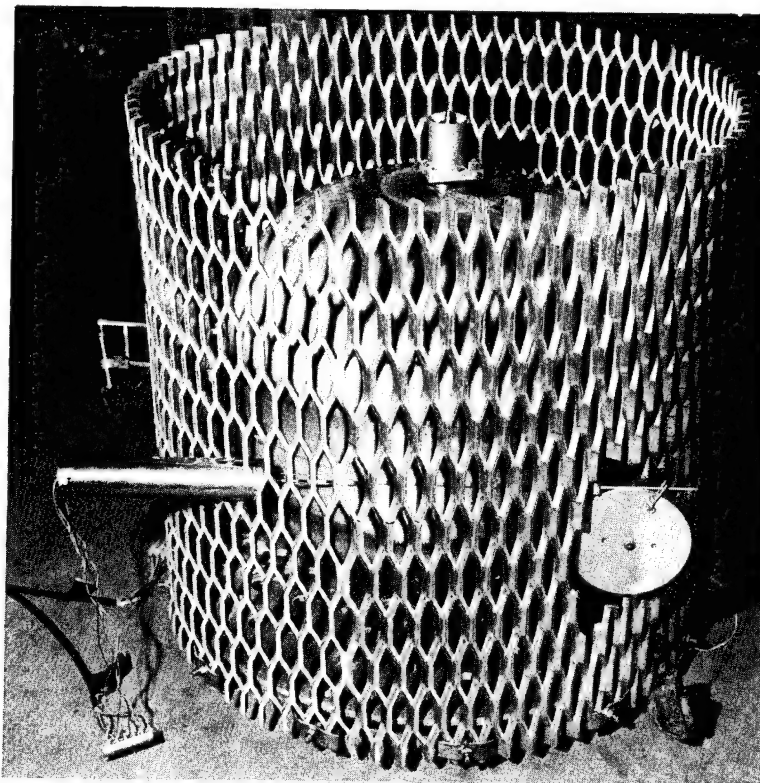
Figure 41 Side View of Overwrapped Test Tank  
Showing Hoop Strain Displacement  
Instrumentation

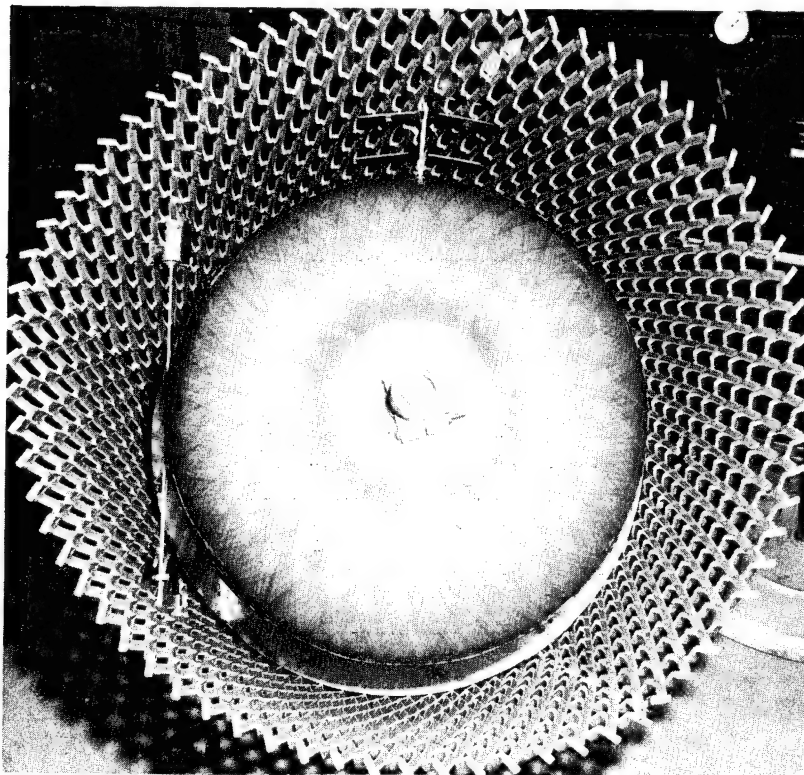
Figure 42 Top View of Instrumented Overwrapped Test  
Tank Mounted in Fragmentation Shield

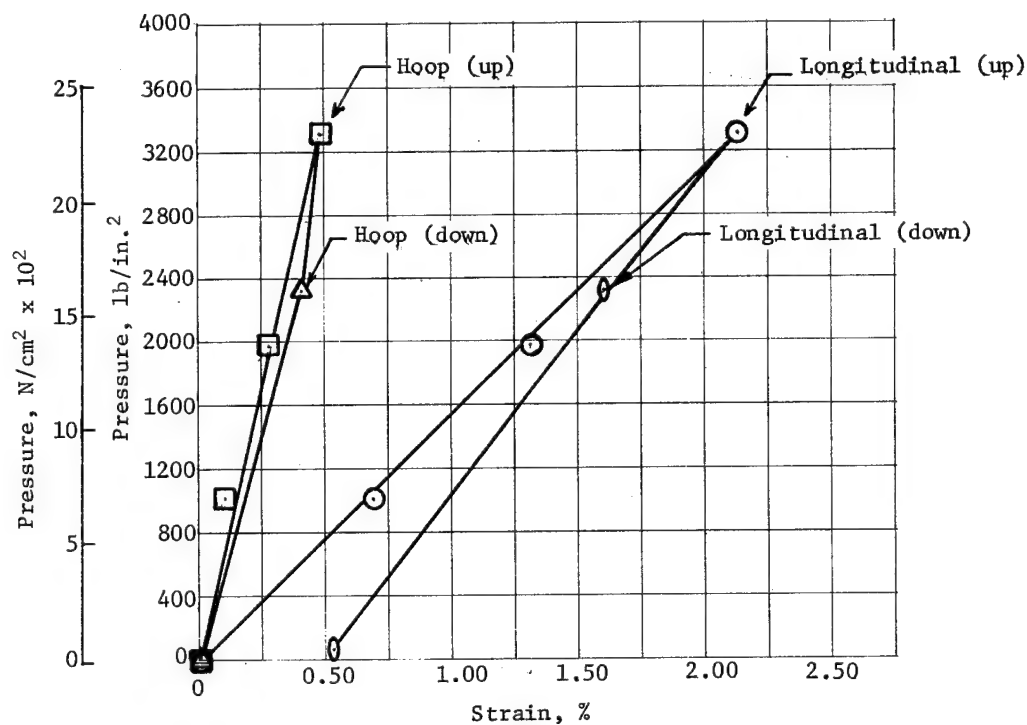
Figure 50 is the strain curve generated in the first cycle pressure test of S/N 6. Succeeding cycles are not plotted since they essentially duplicate the first cycle.

Figure 50 S/N 6 Cycling Test (First Cycle)

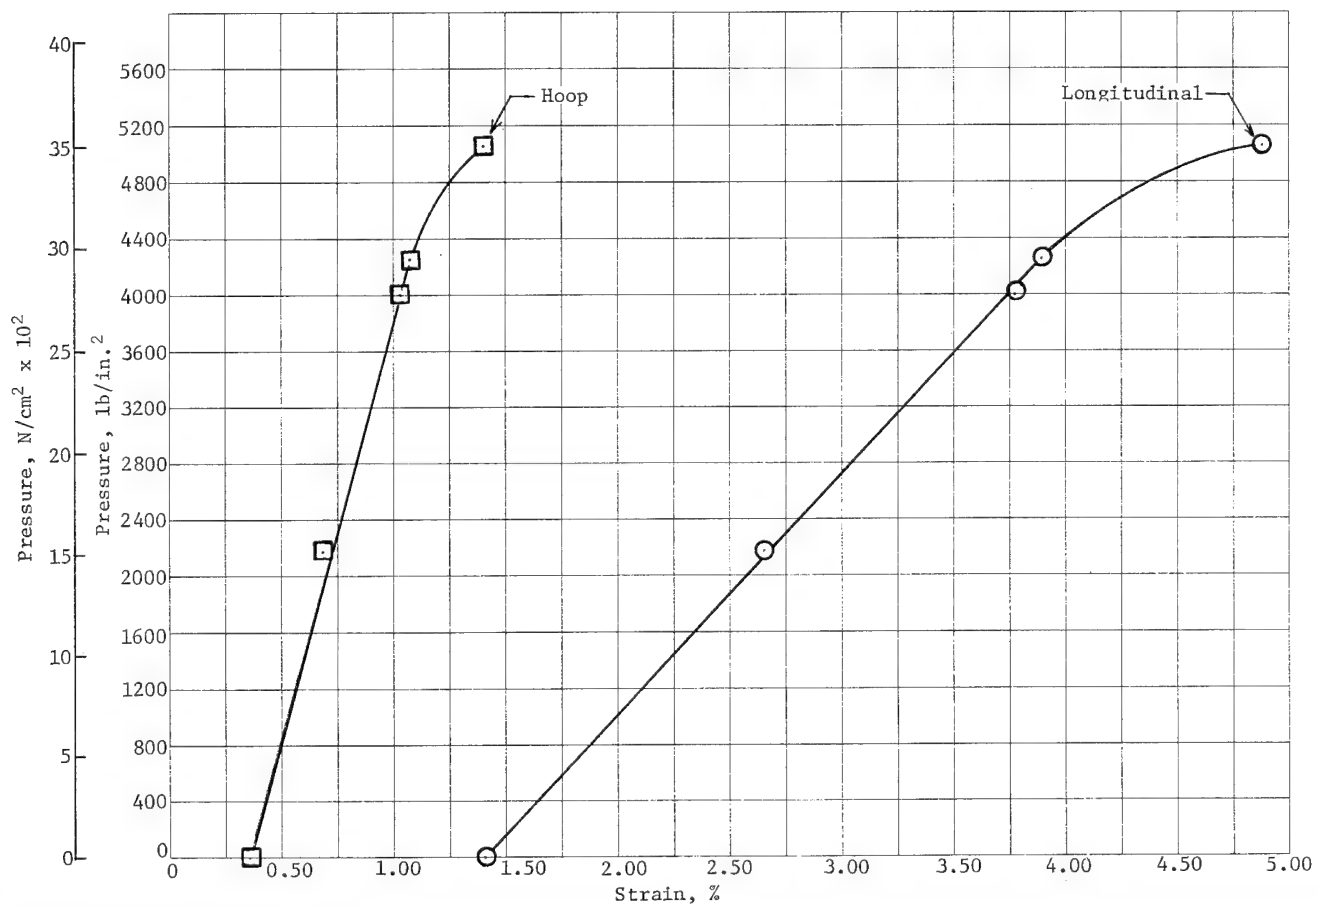
Figure 52 is the strain curve generated during ambient burst test of S/N 7. It is interesting as well as predictable to note that there are residual strains in S/N 7 after it was sized and depressurized. No attempt has been initiated to draw any conclusions from these data because S/N 7 was the only tank tested in this manner.

Figure 52 S/N 7 Burst Test

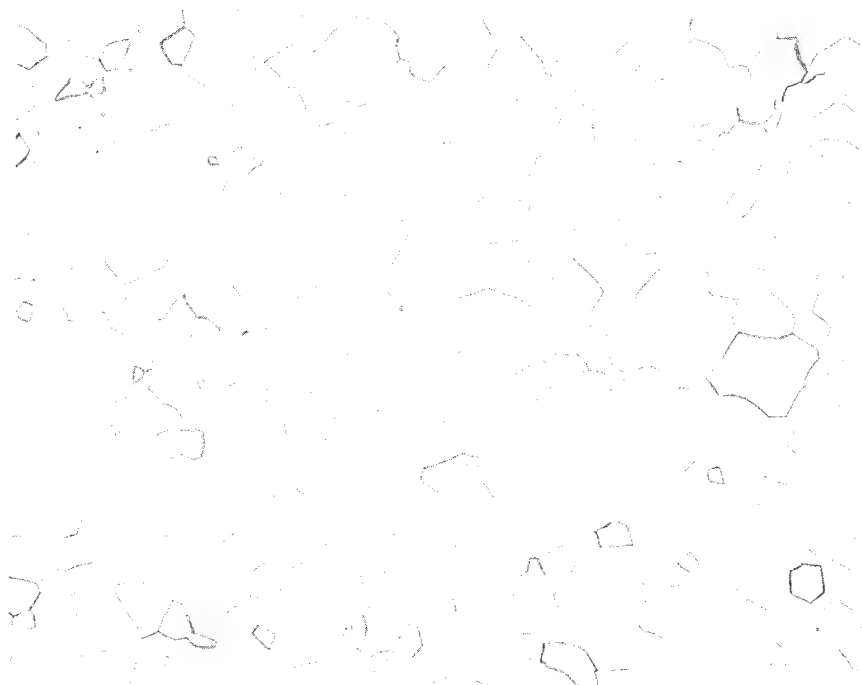
A helium leak check revealed the leak to be in the parent material (Fig. 68 and 69). Dissection of the specimen at the failure point indicates the possibility of stress corrosion (Fig. 70 and 71). In addition, the microstructure near the failure point appears to have a grain boundary precipitant typical of overannealing or overheating. Figures 72 and 73 show comparisons of normal "clean" microstructure versus the "dirty" microstructure near the failure point.

Figure 72 Photomicrograph of Normal "Clean" Microstructure (100X)

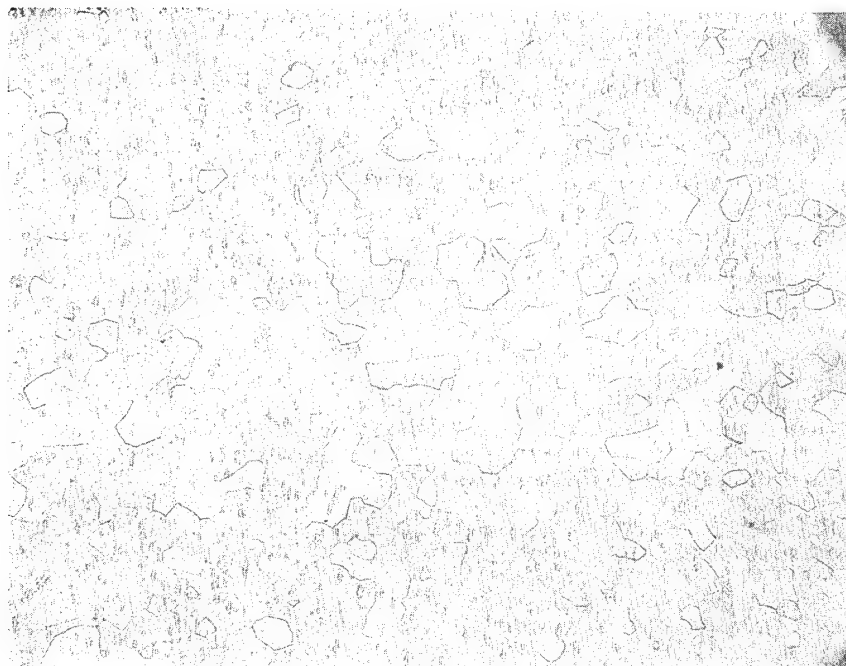
As a result of the 1-hour tests and the 2-hour tests at higher temperature, it was decided that the ductility (Fty and %e) would be best at around 1650°F. Subsequent tests at different times showed the best combination of Fty, %e, and grain structure to be around a 4-hour anneal at 1660°F.

Figure 10 Photomicrograph of Longitudinal Cross  
Section at 100X of C Plate Annealed  
1 hour at 1660°F

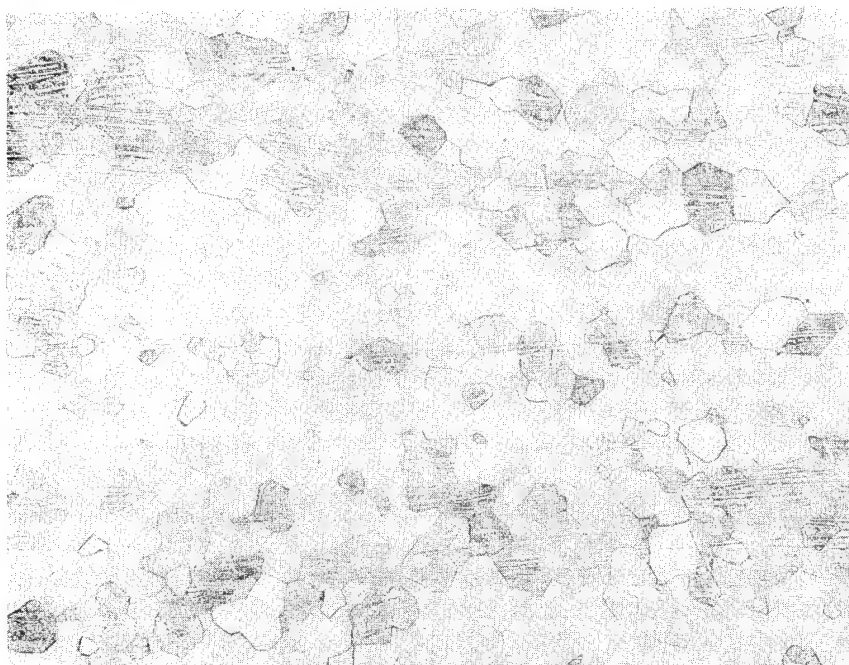
Figure 15 Photomicrograph of Longitudinal Cross  
Section at 100X of C Plate Annealed  
4 hours at 1660°F

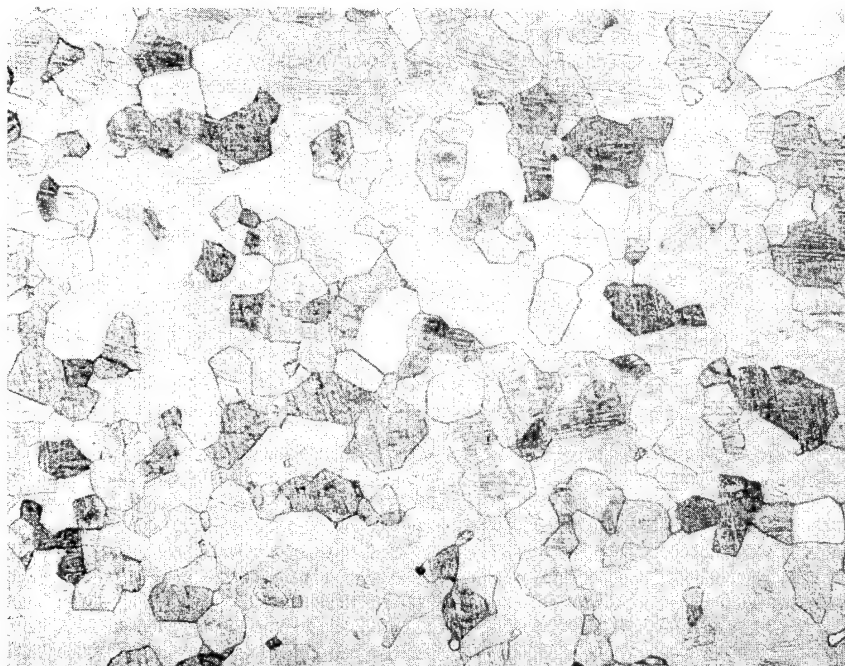
Figure 16 Photomicrograph of Longitudinal Cross  
Section at 100X of C Plate Annealed 8  
hours at 1660°F

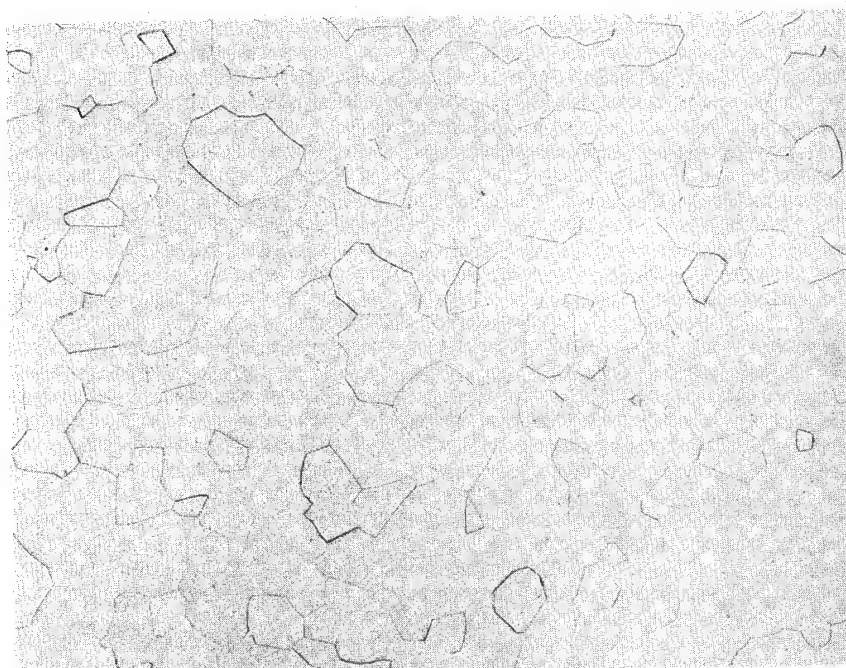
Figure 17 Photomicrograph of Longitudinal Cross  
Section at 100X of C Plate Annealed  
24 hours at 1660°F
